International Conference on Concentrating Solar Power and Chemical Energy Systems,  
SolarPACES 2014

## Critical constraints responsible to solar glass mirror degradation

R. Girard<sup>a</sup>, C. Delord<sup>a</sup>, A. Disdier<sup>a</sup>, O. Raccurt<sup>a\*</sup>

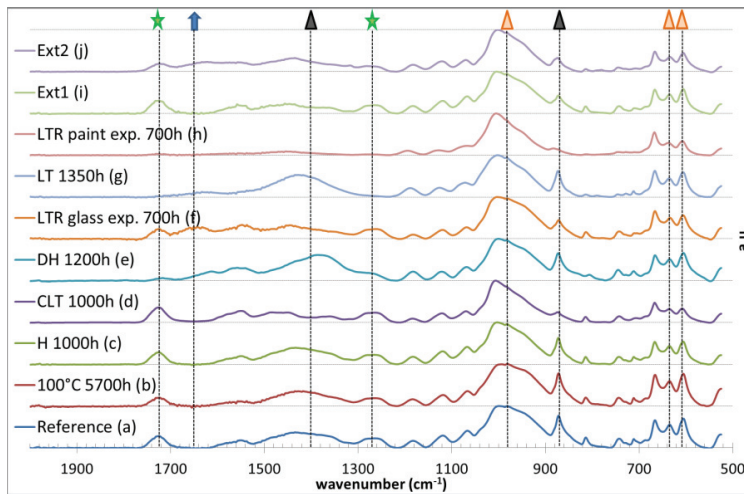
Paint degradations change drastically as a function of constraints exposure (Fig. 2). Results obtained by FTIR-ATR show that temperature does not affect the paint structure even after 5700h at 100°C (Fig. 2b). At low temperature (45°C) and with high humidity level (95% RH), the chemical structure of the paint does not change either (Fig. 2c). In the same conditions, but with liquid water (Fig. 2d), the paint binder remains unchanged but a depletion of pigments content is observed for  $\text{CaCO}_3$  (1400 and 875  $\text{cm}^{-1}$ ) and  $\text{BaSO}_4$  (980, 640 and 610  $\text{cm}^{-1}$ ).

At low temperature and at relatively short time (1000h), humidity has no effect on paint degradation but at high temperature (85°C), the paint is rapidly deteriorated (Fig. 2e). IR measurements after 1200h of DH test show binder degradation whereas the pigment contents are not affected. The decrease of intensity at 1720 cm<sup>-1</sup> (C=O) and the appearance of a new vibration band around 1620 cm<sup>-1</sup> are caused by the degradation of the polymer binder and the formation of hydrolysis products [11]. At the same time, the decrease of the band at 815 cm<sup>-1</sup> evidences the break of crosslink between alkyd and melamine. The ageing under irradiation with glass exposition to the light allows us to understand the combined effect of liquid water and temperature. The analysis was performed on the water retention area (Fig. 2f). This ageing induces a vibration band appearance around 1650 cm<sup>-1</sup> due to binder hydrolysis. But in addition to the polymer degradation, a loss in the CaCO<sub>3</sub> content is observed (1400, 875 and 710 cm<sup>-1</sup>).

Fig. 2: Spectra of alkyd paint (mirror #1) obtained by FTIR-ATR between 500 and 2000 cm<sup>-1</sup> after different kind of ageing test (exp. means exposure). Arrow corresponds to a new band vibration caused by degradation products.

When paint is directly exposed to irradiation (LT), the degradation level is very high (Fig. 2g). The vibration bands of C=O bonds around  $1720\text{ cm}^{-1}$  disappear associated with the growth of a large band around  $1650\text{ cm}^{-1}$  caused by appearance of photo-oxidation products [8]. At the same time, the crosslinks between alkyd and melamine disappear also ( $815\text{ cm}^{-1}$ ). Despite the strong degradation of polymer matrix, the pigments remain into the paint. In the presence of liquid water (LTR), the degradation is even more severe. A loss of pigments is associated to the degradation of the binder due to irradiation. It is clearly evidenced by IR spectra but also by the observation of chalking. The complete deterioration of the binder and the loss of pigments induce an erosion of the paint until a complete disappearance of the top coat. The degradation mechanism is very fast and it is enhanced by the spreading and flow of water on paint surface.

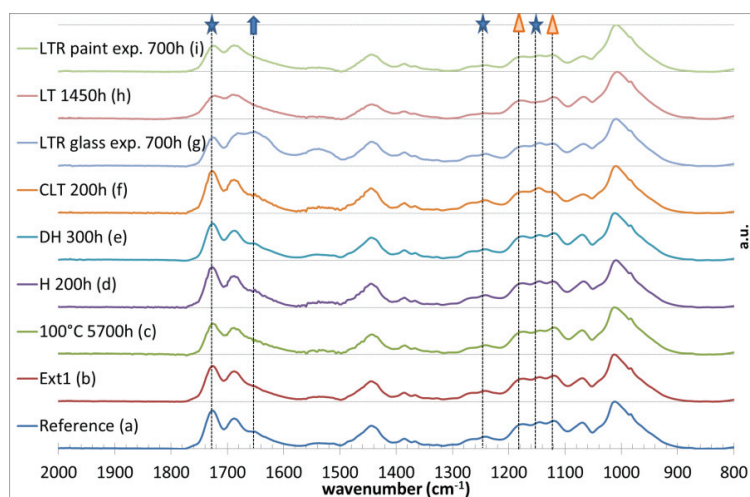
But paint is deteriorated as soon as liquid water is a constraint. At low temperature (CLT), there is only a decrease of absorption at  $1070, 1110$  and  $1180\text{ cm}^{-1}$  (Fig. 3f). The much probable hypothesis is a loss of  $\text{BaSO}_4$  pigments. At high temperature with liquid water retention (LTR with glass exposed to light), there are a binder degradation and a loss of  $\text{BaSO}_4$  pigments. The decrease of the C=O band at  $1720\text{ cm}^{-1}$  and the appearance of intense vibration at  $1650\text{ cm}^{-1}$  evidence hydrolysis of polymer binder (Fig. 3g).

The paints exposed to irradiation (LT) are deteriorated by photo oxidation mechanisms (Fig. 3h). The enlargement of the C=O band ( $1720\text{ cm}^{-1}$ ) corresponds to this mechanism. The decrease of absorption at  $1520\text{ cm}^{-1}$  indicates a degradation of urethane bonds.

Fig. 3: Infrared spectra of top coat #2 obtained by FTIR-ATR between  $800$  and  $2000\text{ cm}^{-1}$  after artificial ageing test.

One can also observe that the intensity at  $1150\text{ cm}^{-1}$  decreases whereas the vibration band at 1070, 1110 and  $1180\text{ cm}^{-1}$  remain unchanged after LT ageing. Thus, the  $\text{BaSO}_4$  pigments are not affected by photo-ageing and the decrease at  $1150\text{ cm}^{-1}$  is attributed to polymer degradation. When paints are exposed to continuous irradiation but with rain cycle (LTR) the same kinds of photo-oxidation are observed (Fig. 3i). However, the decrease of the absorption between 1100 and  $1200\text{ cm}^{-1}$  indicates a loss of  $\text{BaSO}_4$  pigments due to spreading and flow of water.

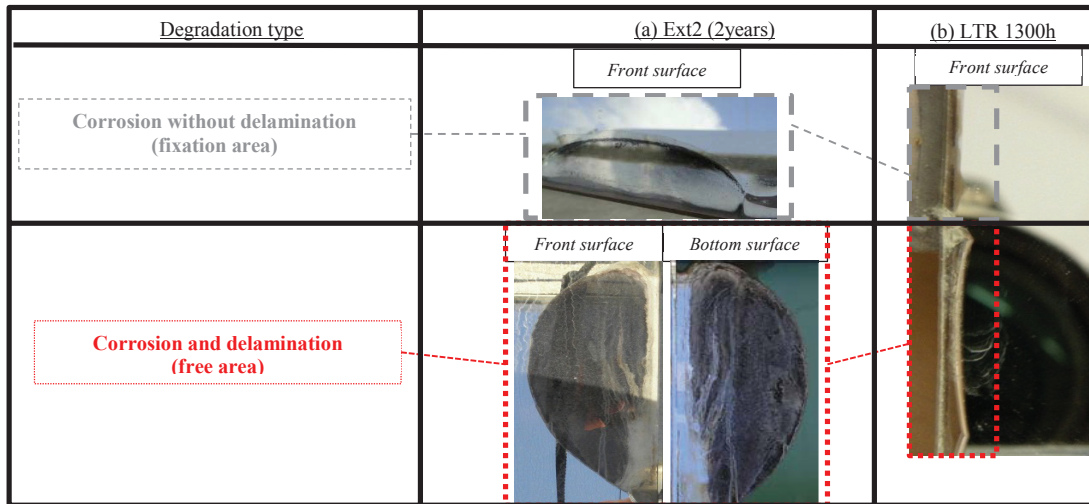
Silver corrosion starts from the edges of the mirrors and may go along with delamination of the paint system. These phenomena were firstly observed in natural ageing Ext2 (Fig. 5a). Two kinds of degradation were observed depending on the fixation system of the mirrors. Under the fixation of the mirror there is corrosion from the edge but no delamination. On the other hand, the corrosion from the edge goes along with delamination. These phenomena happen only with water retention on the paint and when ageing induces temperature and wetting/drying cycles. From this fact observed in Ext2 site (Fig. 5a), we develop a new artificial test with alternation of dry phase and rain phase. This test called LTR in this study is based on the standard ISO 11341.

Optical micrographs Fig. 5b and 6 after LTR ageing for mirror #1 evidence the silver corrosion and the delamination of the paints system. The degradations are in really good agreement with what occurs in outdoor ageing Ext2. This confirms assumptions that water retention associated with temperature cycle are the critical constraints responsible to silver corrosion and paint delamination. Mirror #2 is also subject to these phenomena (Fig. 7). Silver corrosion is observed in Ext2 ageing whereas silver corrosion and delamination is already observed on LTR after 1300h of ageing. Mirror #3 is not corroded at all in Ext2 and in LTR test. This is another fact which confirms the relevance of the LTR test. All the mirrors do not have edge protection by paint, polymer or scotch because samples are cut from larger mirror. The well edge resistance of mirror #3 shows that a better edge protection can be guarantee by the mirror technology itself without applying an edge protection system.

Results show that the degradation mechanism from the mirror edge starts with the silver corrosion due to water retention. This corrosion decreases the adhesion between the metallic layer and the paints system. The paint degradation (Fig. 2) induces modifications of chemical properties of paints such as wettability and water absorption. Physical properties like coefficient of thermal extension or tensile and compression strength may also be affected. Temperature changes and cycle of humid and dry phases induce strains which cause delamination of the paint when corrosion of metallic has already begun.

Fig. 5: Photographs of the mirror #1 degradation after 2 years Outdoor (Ext 2) and after artificial ageing (LTR).

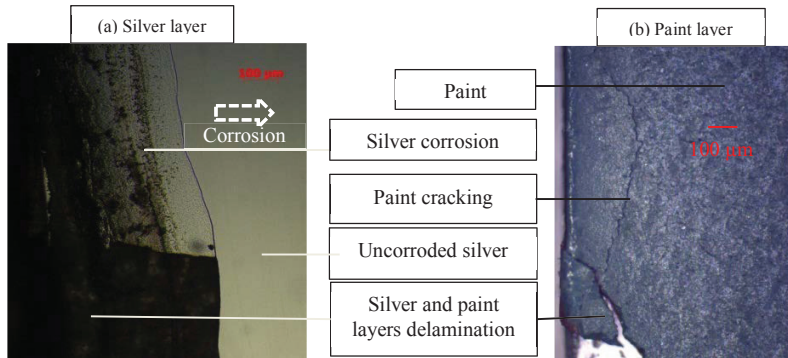
Fig. 6: Optical micrograph of corrosion of the silver layer and delamination of paint system after 450h of artificial ageing LTR.

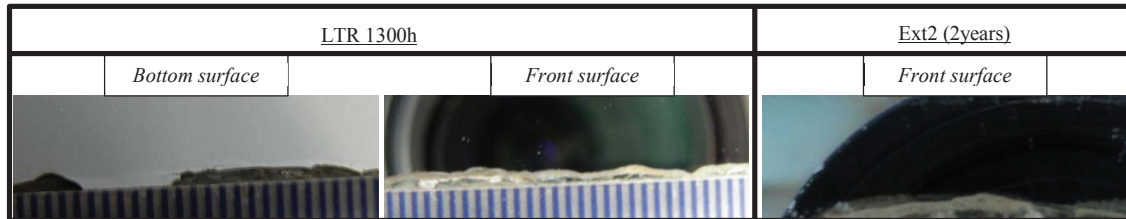
Fig. 7: Photographs of the mirror #2 degradation after Outdoor (Ext 2) and artificial ageing (LTR).

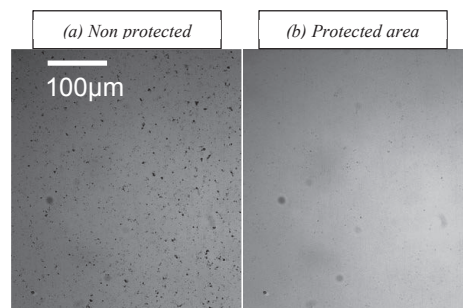
The homogenous degradation of silver layer is a whole corrosion of silver by pitting (Fig. 8). Results displayed at tables 4, 5 and 6 show that homogeneous corrosion of silver layer happens after some thousands of hours at 100°C for all the mirrors, after two years of Ext1 ageing for mirror #1 and after only 100h of damp heat test for mirror #2. Except for mirror #1 subjected to Ext1 ageing, the silver corrosion is not associated with a chemical degradation of the paint.

The homogeneous degradation of model mirror (#1) after two years in Ext1 can be attributed to the loss of mineral pigments which favors the diffusion of corrosive species. This kind of degradation is not observed for mirrors exposed in Ext2. The higher humidity level and rain frequency at the Ext1 site may cause this global degradation. It is interesting to notice also that one part of the mirror is not exposed to solar irradiation due to fixation mechanism. The silver area below this fixation mechanism is not corroded. These results suggest that UV rays catalyze chemical reaction of corrosion. Authors had already shown that UV rays above 450 nm are partially transmitted through silver layer and can degrade silvered PMMA mirrors [13]. On one hand, transmitted UV can deteriorate the paint and on the other hand they can catalyze chemical reaction with corrosive species. We need to have more feedback on solar mirror technology to confirm this fact but this result suggests that mirrors have to be exposed to UV in artificial ageing test in order to evaluate their lifetime. However, one has to remember that model mirror #1 have no copper layer between silver layer and paint coat. As long as copper layer or any kinds of anti-UV coats remain unchanged, this kind of degradation should not occur.

Fig. 8: Optical micrograph of silver layer after 2 year in Ext1.
