International Conference on Concentrating Solar Power and Chemical Energy Systems,  
SolarPACES 2014

## Critical constraints responsible to solar glass mirror degradation

R. Girard<sup>a</sup>, C. Delord<sup>a</sup>, A. Disdier<sup>a</sup>, O. Raccurt<sup>a\*</sup>

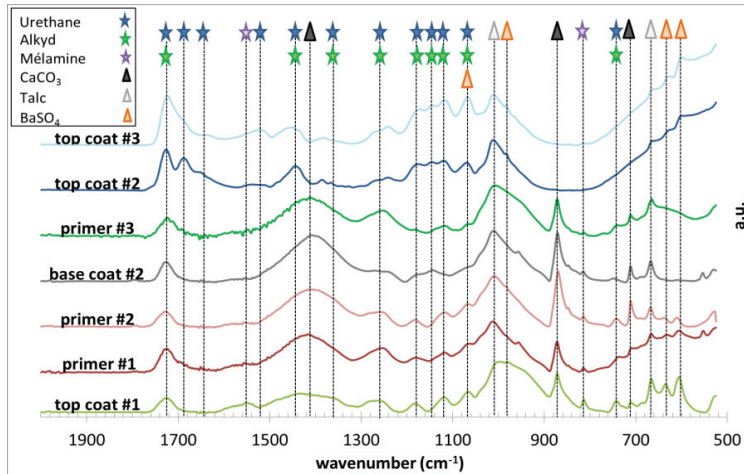
Paint degradations change drastically as a function of constraints exposure (Fig. 2). Results obtained by FTIR-ATR show that temperature does not affect the paint structure even after 5700h at 100°C (Fig. 2b). At low temperature (45°C) and with high humidity level (95% RH), the chemical structure of the paint does not change either (Fig. 2c). In the same conditions, but with liquid water (Fig. 2d), the paint binder remains unchanged but a depletion of pigments content is observed for  $\text{CaCO}_3$  (1400 and 875  $\text{cm}^{-1}$ ) and  $\text{BaSO}_4$  (980, 640 and 610  $\text{cm}^{-1}$ ).

Fig. 1: Spectra of paints obtained by FTIR-ATR between 500 and 2000cm<sup>-1</sup>.

The absorption of water into the paint may favor migration of mineral pigments towards the surface. No reduction of talcum content was observed because these silicate pigments have a lamellar shape; they are consequently much less mobile than others.
